Why City Buildings Are Needed

Why a change in city office buildings is needed may not be readily apparent to the casual observer. This document examines the needs of the Fire Department, Police Department and the City Offices.

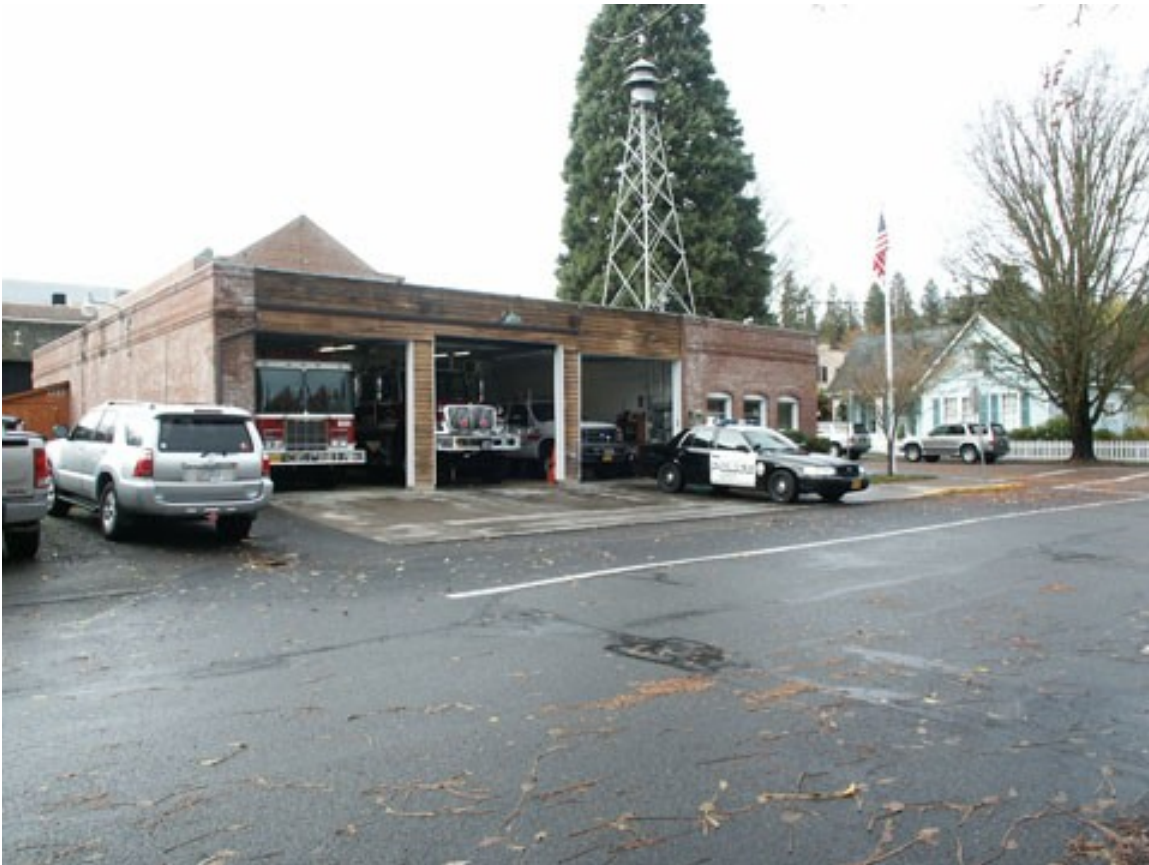
Figure 1

The Fire Department is currently housed in a cinder block brick veneered building on the corner of “C” and Third Streets. As can be seen from the photos, the building is land-locked, and relies on the good graces of the adjoining property owner for storage and parking. The “apron” [Figure 1] (truck parking) in front of the station extends into “C” street. The cinder block building exhibits cracking and settling, smoke and fire penetrations through existing walls and rooms which are inadequate in size. [Figures 2 and 3] The bay, where the trucks are stored, has been modified to accommodate the larger trucks currently in use. There is inadequate space for storage of equipment and movement around the vehicles. [Figures 4 and 5.]

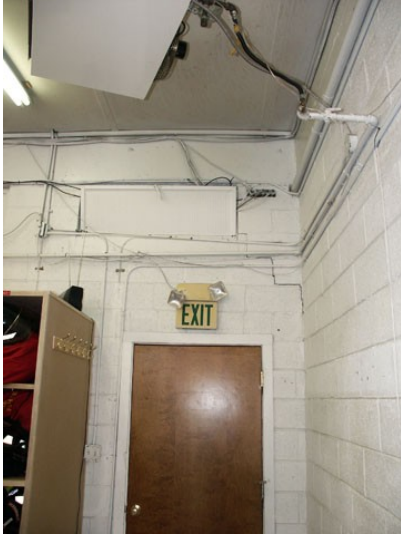
Figure 2 (left) shows cracking in the top right corner above door frame, loose barrier above door and smoke and fire penetrations in walls and ceilings. Figure 3 (right) shows severe cracking below and behind electrical panels. Storage of flammable materials around electrical panels.

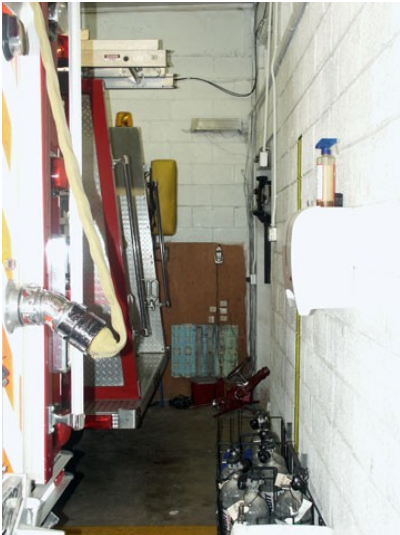
Figure 4 (left) approximately 12 inches of walk space between wall, stored items and back of fire truck. Figure 5 (right) insufficient equipment storage and minimal aisle space in storage area.

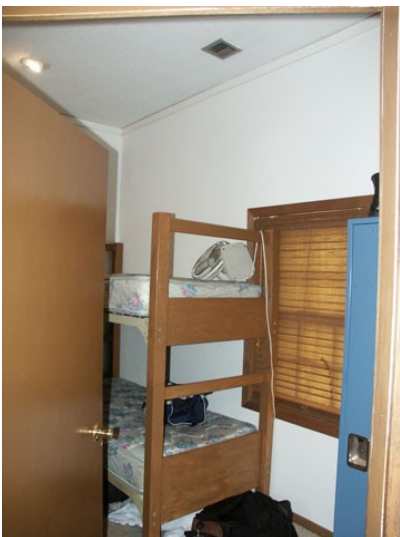
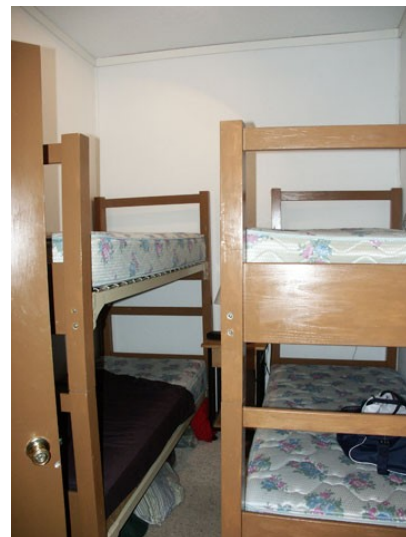
The sleeping accommodations for the fire fighters are sub-standard. [Figures 6 and 7.]

Figure 6 (left) and Figure 7 (right) are of the bunk room. The door can not be completely opened because of the second set of bunks.
